Port State Control - Top detention items

Reduce the risk of detentions

2009 edition

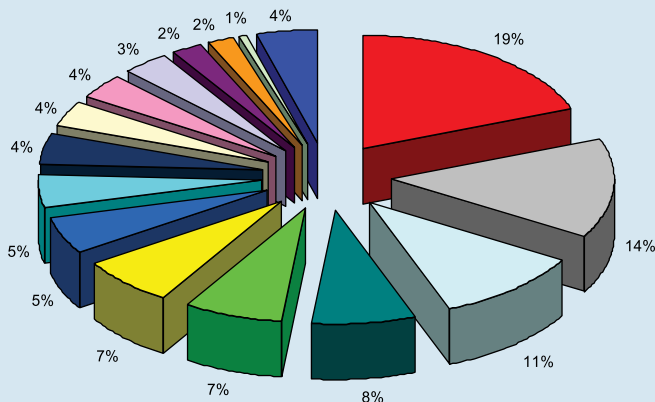
Detention deficiencies per Category Group found on DNV Ships in 2006-2008

Name of category & Number of Deficiencies [Total/Detainable]

- Fire safety measures [848/308]
- ISM related deficiencies [417/224]
- Life safety measures [548/172]
- Propulsion and auxiliary machinery [520/123]
- MARPOL - Annex I [276/121]
- Stability, structure and related equipment [450/110]
- Load lines [327/88]
- Safety of navigation [442/73]
- Ship's certificates and documents [232/71]
- MARPOL- (Annex II,III,IV,V & operational) [193/59]
- STCW [153/58]
- Radio communications [201/54]
- SOLAS related operational deficiencies [162/32]
- ILO 147 (Accommodation, Food&Catering, etc.) [464/31]
- Maritime security [64/12]
- Other [258/70]

The chart on the following page shows the percentage of detention deficiencies sorted by main category group found by PSC on DNV classed ships during the period of 2006 to 2008, sorted by main category group.

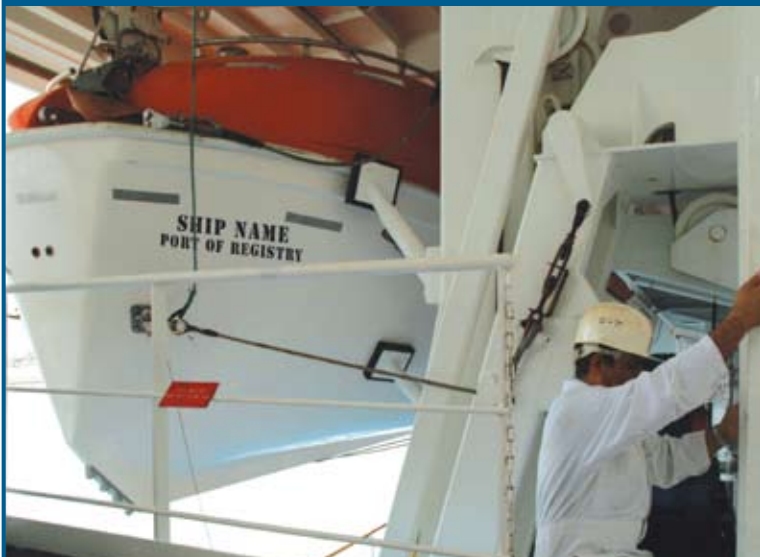
Lifeboat

PSC Finding: Starboard lifeboat's motor could not be started. Crew took over twenty minutes to start engine. A second attempt to start also failed (ground for detention).

- Free access
- Deterioration of hull material.
(e.g. reinforced fibre glasses)
- Propeller & rudder in good working condition
- Engine easily started
Inoperative engine is one of the most common defects
- Release mechanism
- Complete inventory
(proper quantity, date of expiry and good condition)
- Launched every 3 months

Repaired: The injector of the engine has been cleaned and overhauled. Upon completion proper starting of the engine was demonstrated by the crew.

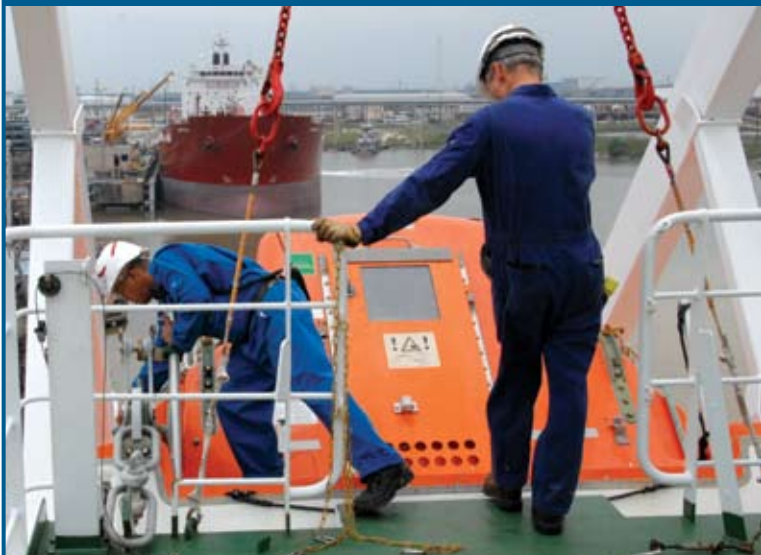
Launching arrangements

PSC Finding: Port & Starboard Lifeboat Davit winch foundation found heavily corroded and wasted. Starboard found more corroded than port foundation (ground for detention).

- Davits & winches
Corroded foundation is one of the most common defects
- Wires & hooks
- Remote control
- Recovering gear
- On-Load and Off-load release
- Guide rollers
- Manual brakes
- Limit switches
- Periodical inspection
- Instructions of maintenance & service

Rectification: Starboard winch foundation previously renewed. Port lifeboat winch foundation renewed and on survey found in order, winch assembly refitted with new bolts and lock washers.

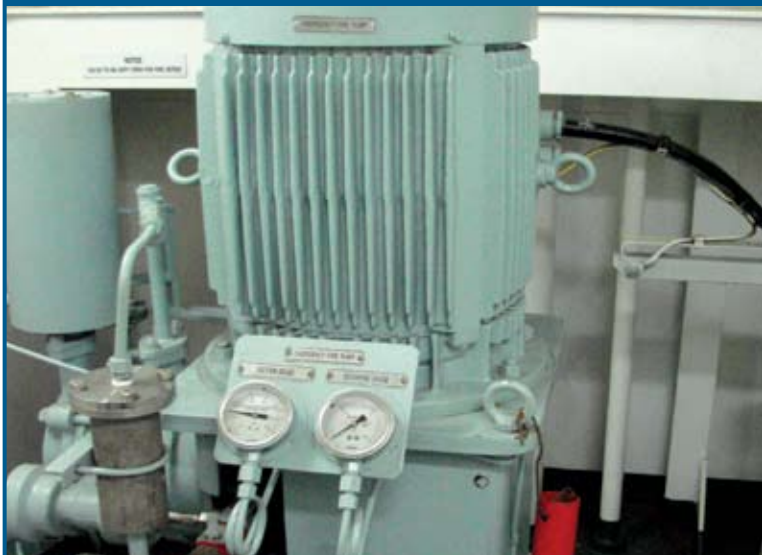
Emergency Fire Pump

PSC Finding: Emergency fire pump failed to start after blackout. During testing of the emergency fire pump by the PSC Officer, the pump failed to pick up suction after 20 minutes (ground for detention).

- Good operating condition
- Self priming
- Ready to use at all times
- Test starting arrangements
- Sufficient pressure to fire lines
Insufficient pressure is one of the most common defects
- Operating instructions are posted in plain view

Rectification: The fire pump remote sea suction valve was found closed due to lack of hydraulic operating pressure. The hydraulic pressure was restored and the fire pump was re-tested and found in order.

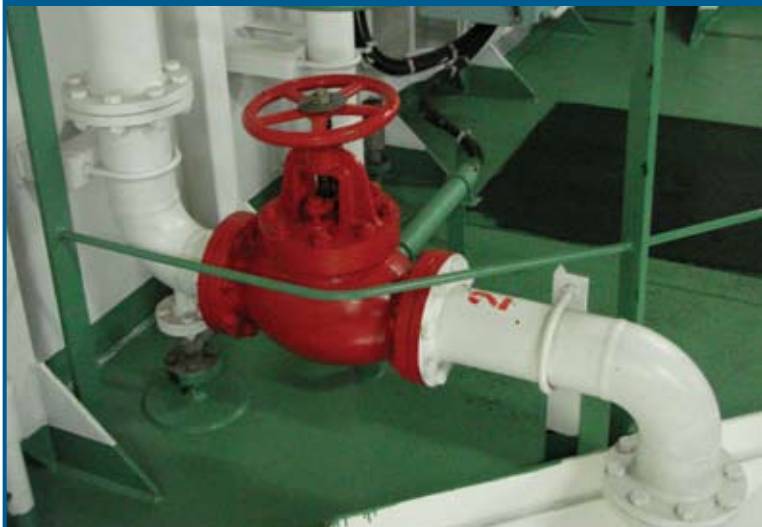
Fire main, hydrants & hoses

PSC Finding: Fire line in engine room leaked. Wastage on fire main and deck foam line was observed (ground for detention).

- Free from leaks
Leakages on fire line or fire hose is one of the most common defects
- Hydrants valves moving freely
- Nozzles in place and in good working condition
- Pressure tested

Repaired: The leaked fire line was permanently repaired. The pipe replaced. UTM from fire main & deck foam line was taken and wasted length partly renewed. Pressure test was carried out and no leakage observed.

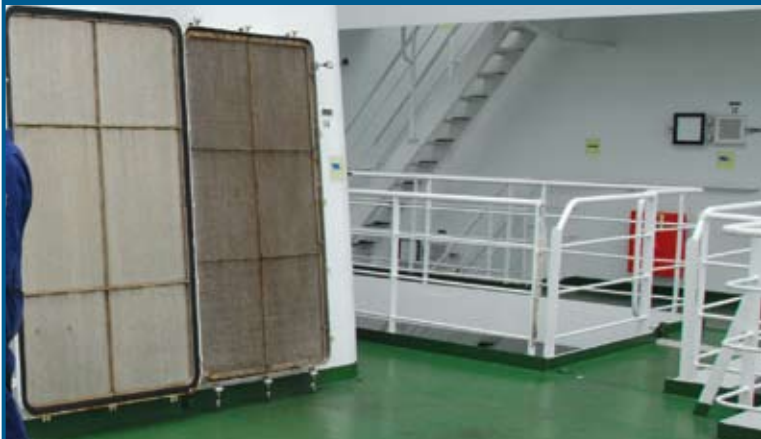
Fire dampers & ventilation

PSC Finding: Several fire flaps not operable; corroded and seized closing device (ground for detention).

- No damages or corrosion
Seized fire dampers is one of the most common defects
- Moving freely
- Locking device
- Sealing rubber
- Regularly tested

Rectification: A number of fire flaps were found in very poor condition or not operable at all. The ducts containing the actual fans (and supports for electric motors) were found holed and thin. These ducts were now temporary repaired by doubler plates, but need to be renewed; condition of class issued. Several accommodation and galley fire dampers were found without operating cable attached. This was all rectified.

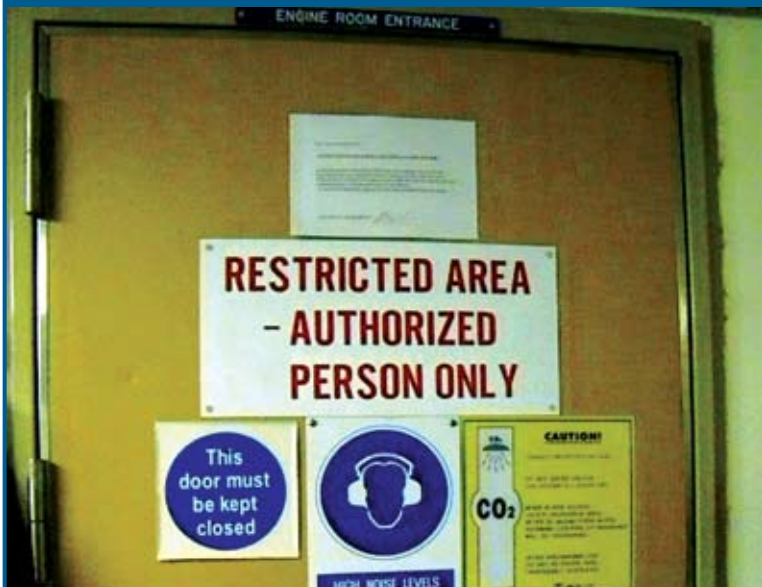
Fire & weathertight doors

PSC Finding: Doors within main vertical zone – malfunctioning closing device for door in Engine room (ground for detention).

- Well maintained
- Hold back arrangements
- Closing device
 - Door not closing properly is one of the most common defects*
- Clamping devices - doors can be operated from both sides
- Hinges
- Gaskets and sills

Rectification: The closing device was repaired and tested. Found in order.

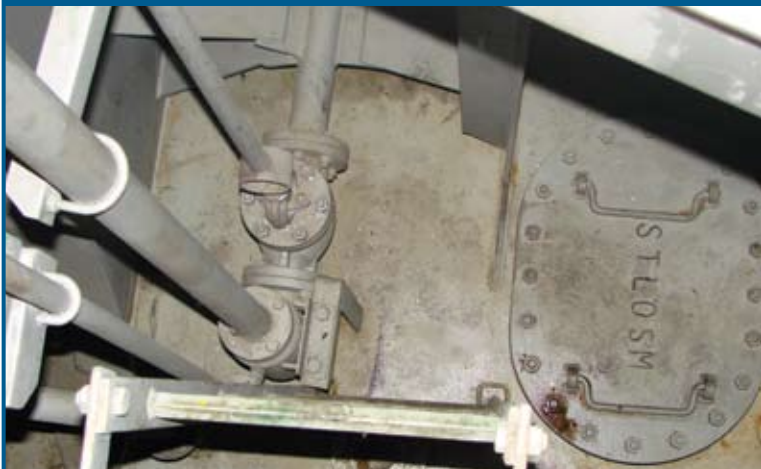
Cleanliness in engine room

PSC Finding: Excessive oil leaking from the ships service diesel generators and the main engine. The oil has coated the machinery, collected in the surrounding bilges, saturated the lagging in the associated piping, and has covered the engine room deck plates. The condition of the engine room presents a significant fire and safety hazard to the vessel and crew (ground for detention).

- Free from leaks
Dirty engine room is one of the most common defects
- Bilges and drip trays are clean
- Oily rags and waste disposed in special container
- Platforms and ladders not slippery
- Safe access - no obstruction by buckets, drums etc.

Rectification: Excessive oil in engine room cleaned as much as possible, oil leaks from main and auxiliary engines brought under control and some of the damaged/oil permeated lagging of pipes changed. Condition of class given for further examination of main and aux. engine; in the meantime ER to be continuously manned (EO notation suspended).

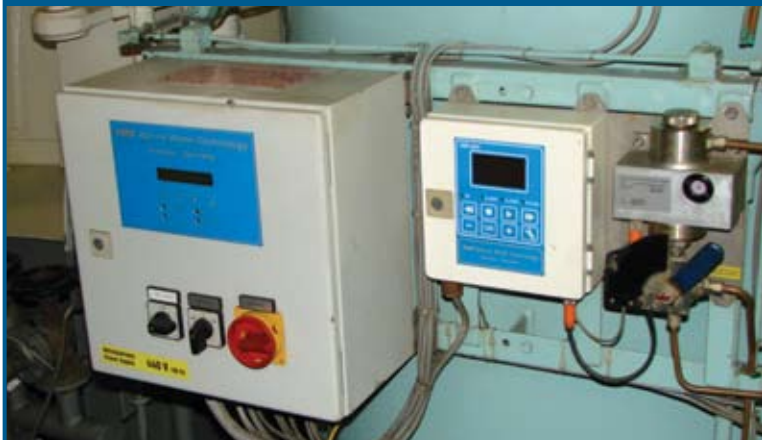
Oil filtering equipment & 15 ppm alarm

PSC Finding: After 45 min of trying the chief engineer was not able to prove proper operation of OWS. He also could not provide manufacturer's manual...overboard discharge valve was found to be seized in closed position and inoperable...PSC verified 3 separate ways of by passing the OWS and discharge oil directly to sea. An ISM audit to be carried out.

- Good operating condition
Operational failure is one of the most common defects
- 15 ppm alarm arrangements
- Calibrated correctly
- No unauthorized connection overboard
- Spare parts available
- Crew members trained to operate
- Posted operating instructions

Rectification: A new pump was installed. OWS was tested and found in good working condition. 15 ppm alarm and 3 way valve tested and confirmed in operation. Overboard valve tested and found operational. OWS manual (photocopy) was found on board and reviewed. Existing bolted end flange attached to existing pipe work located in between the OWS and 3 way valve was now removed and blanked off. An ISM audit was carried out before departure.

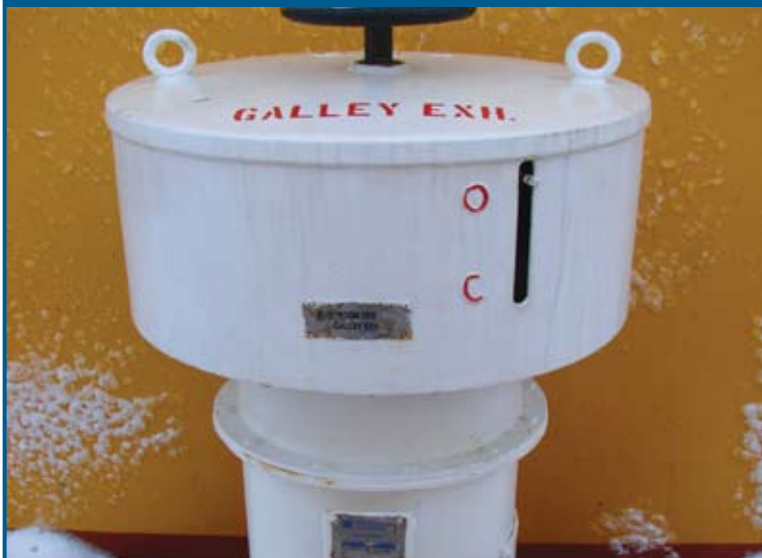
Vent heads, air pipes, goose necks

PSC Finding: Numerous water ballast tank air vent closing devices were found defective; wasted top sealing surfaces (ground for detention).

- Intact and well maintained
- Free from holes, corrosion and damages
Corrosion is one of the most common defects
- Flame screen
- Closing devices moving freely
- Sealing of cover
- Locking arrangement

Rectification: All ballast tank air vent heads were opened and checked. Total 33 pieces of vent head inner rings were repaired by workshop.

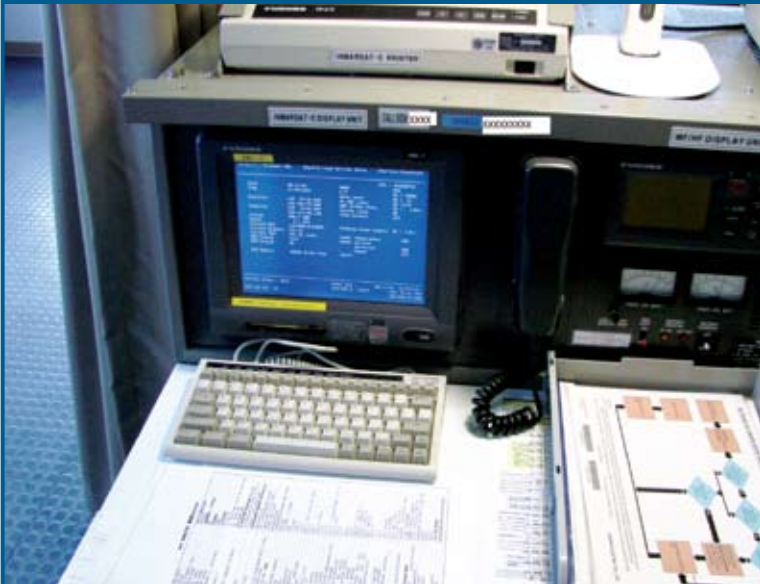
GMDSS radio station

PSC Finding: MF/HF DSC not connected to reserve source of energy (ground for detention).

- Reserve source of energy
- Battery charger
- Battery expiry date
- SART at correct location
- Portable GMDSS VHF
- MF/HF installation
 - Malfunctioning of MF/HF is one of the most common defects*
- Antennas

Rectification: The defective cable supplying power from emergency batteries has been replaced.
